# United States Department of the Interior

## BUREAU OF LAND MANAGEMENT

Re: Encroachment of Mining  
Operations onto Public  
Lands - Horseshoe Bend

YERIAN MINE ENCROACHMENT  
S/047/034 08/05/94  
Sec. 2, T6S, R21E &  
Sec. 35, T7S, R21E  
Uintah County, Utah

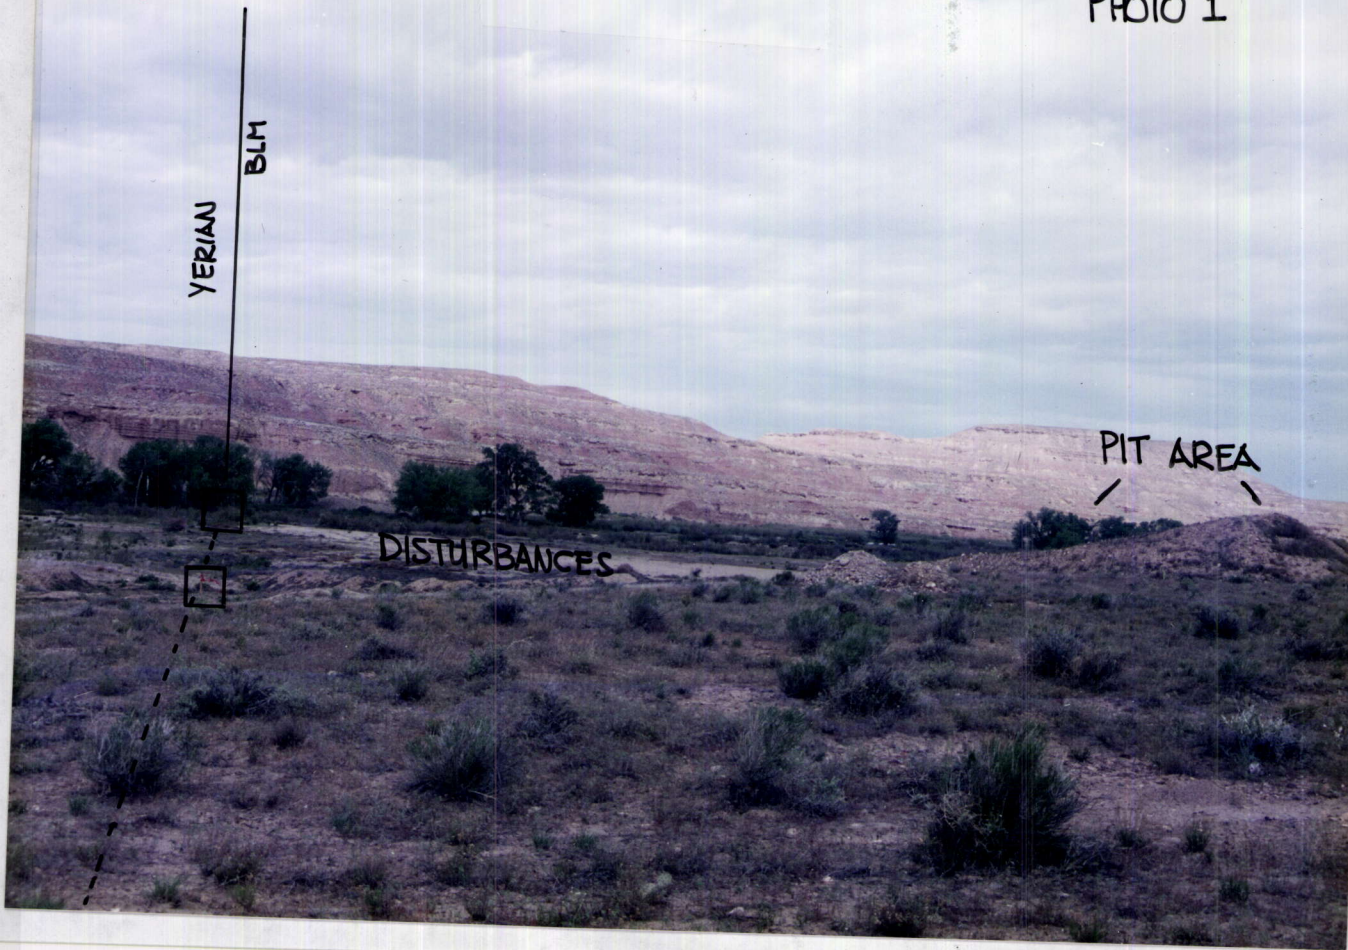
PHOTO 1

- Photo 1: Taken from near the road into the Yerian area, looking in an easterly direction towards the Green River. Orange flagging denotes boundary line. The areas of disturbance encroaching onto BLM lands can be seen in the mid-left area of the photo. The pit/trench area and a pile of talus material are to the mid-right of the photo.

Reclamation of the entire encroachment area(s) shall include, but not be limited to: reshaping of disturbed areas to natural contours, applying topsoil, and revegetating with appropriate seed mixture as required by the BLM Resource Area personnel. A description of the approved seed mixture is included with this correspondence (Exhibit A). Seed shall be applied to the area after September 15th and before the ground freezes. Attempts should be made to control erosion and any noxious weeds invading the site.

All high walls or overburden material piles will be recontoured to slopes not steeper than 3:1 and revegetated using the recommended seed mixture.

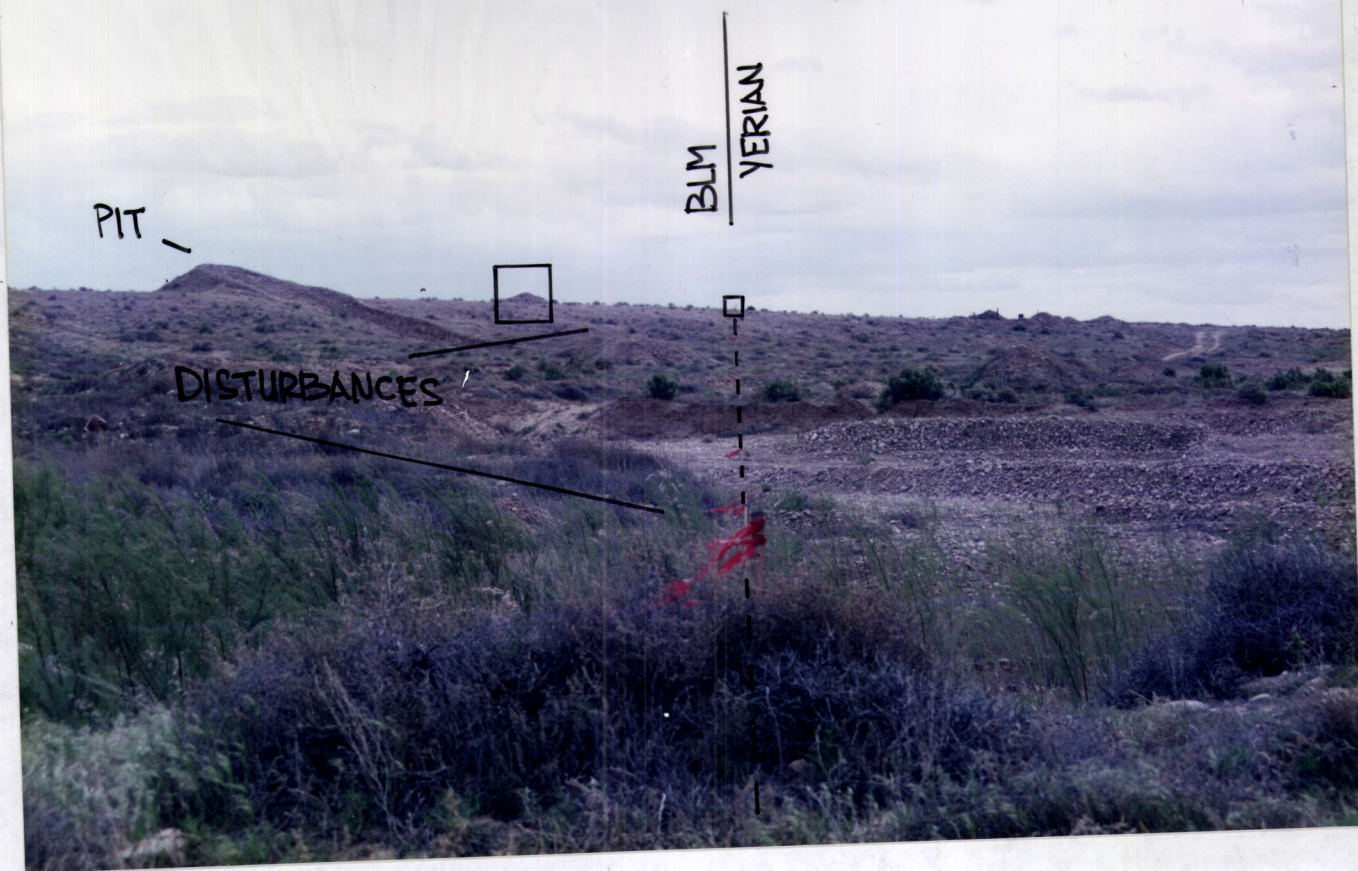
PHOTO 3

- Photo 3: Same as Photo 2 only taken in a horizontal manner to show the outlying area. The pit area and areas of surface disturbance are more apparent in this photo than in Photo No. 2. There appears to be some stockpiled material to the left which could be used to fill in the disturbed areas and assist with seed growth.

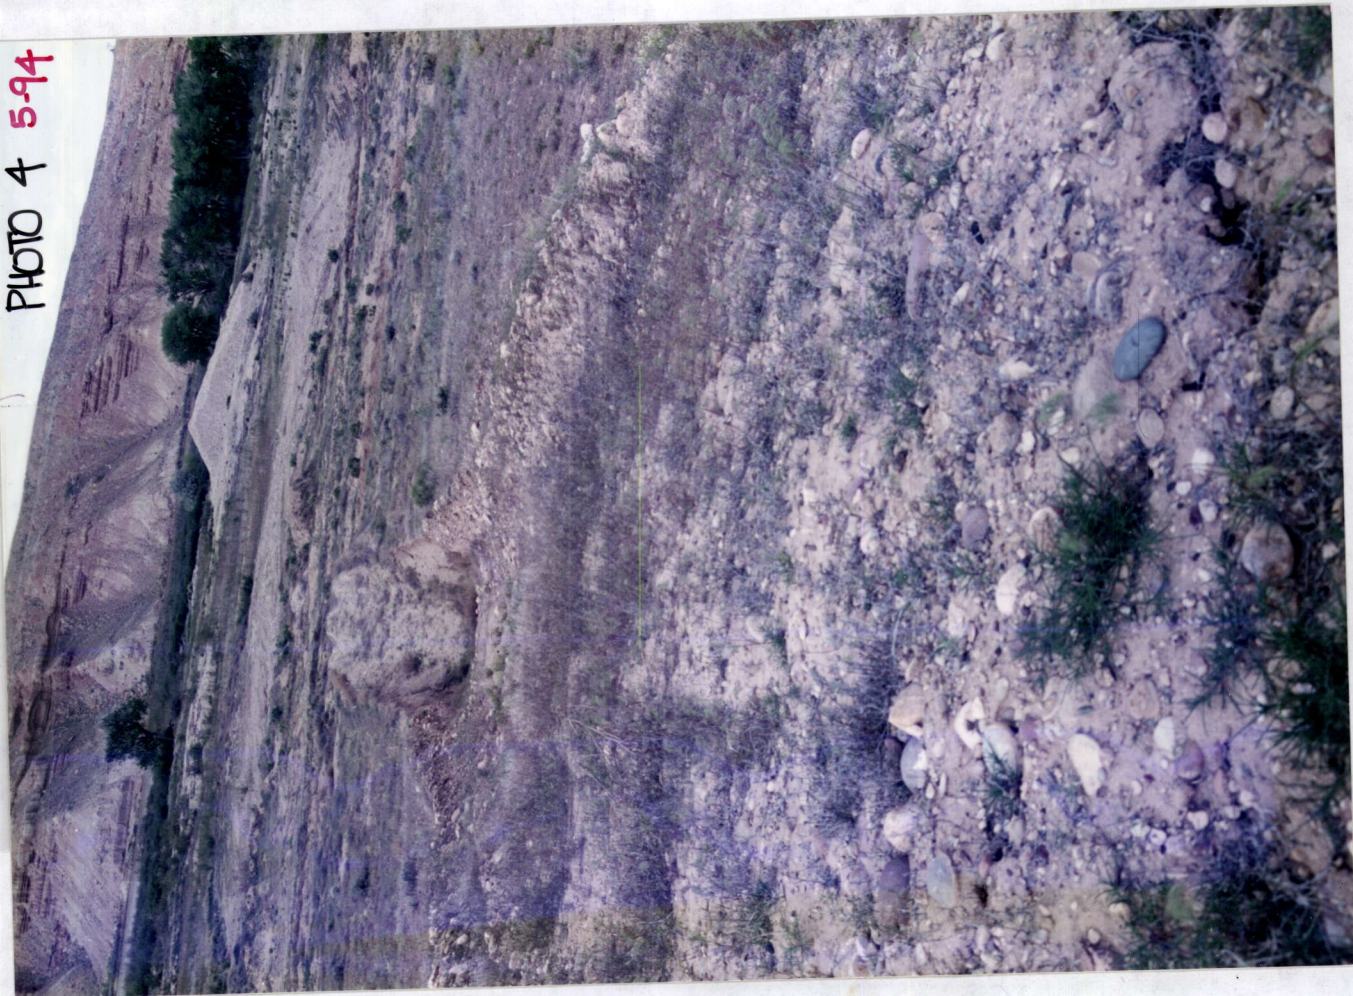
PHOTO 4 5-94

- Photo 4: This photo was taken at the top-most area of the pit to show the depth and width of the trench and pit area. Material at the top of the trenched area could be used to fill in the pit area and some recontouring could be performed to match the surrounding area.
